Homeowner's Guide

# The Life Cycle of Your Roof

What to Expect From Your CertainTeed Roof

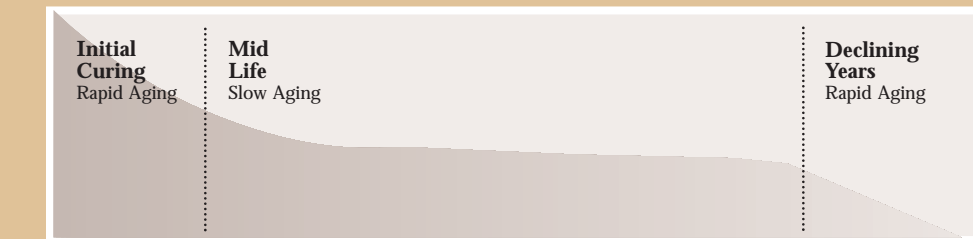
When your new roof was installed, friends and neighbors may have remarked how it enhanced the beauty of your home. However, research indicates that aging begins soon after the shingles are installed and progresses rapidly during the initial curing phase of its life cycle. During this stage, granule loss may occur, small blisters may develop, or the shingles may curl slightly at their edges. You may even notice that this curling is more pronounced during cold weather and the shingles may lie flat as temperatures rise. The good news, however, is that after this curing stage the shingles enter a long period of slow aging, which lasts for the major portion of the shingle's natural life.

During the "mid-life" period, aging continues at a much slower rate. The cracking or granule loss still occurs but does not increase at a noticeable rate. Only after this long period of mid-life does the aging process begin to accelerate once again as the shingles enter their declining years. It's during this period that homeowners normally think about replacing their roofs.
